**THE EFFECTS OF ENVIRONMENT ON THE INTERLAMINAR SHEAR
PERFORMANCE OF AN OXIDE/OXIDE CERAMIC MATRIX COMPOSITE AT
ELEVATED TEMPERATURE**

THESIS

AFIT/GAE/ENY/07-J11

AIR FORCE INSTITUTE OF TECHNOLOGY

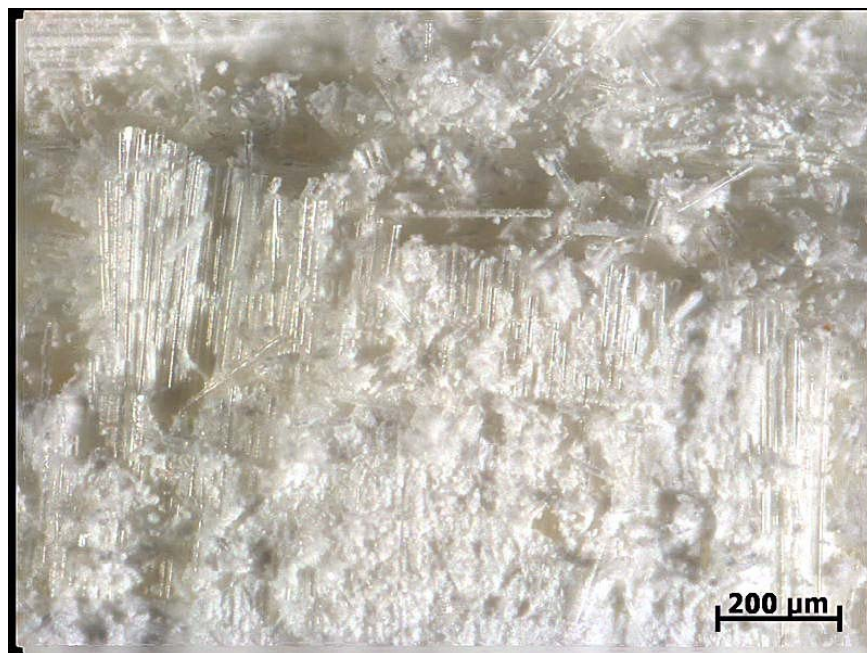
Figure 101: Close-up of piece A of the N720/A specimen tested in creep at -6.5 MPa at 1200 °C in steam.

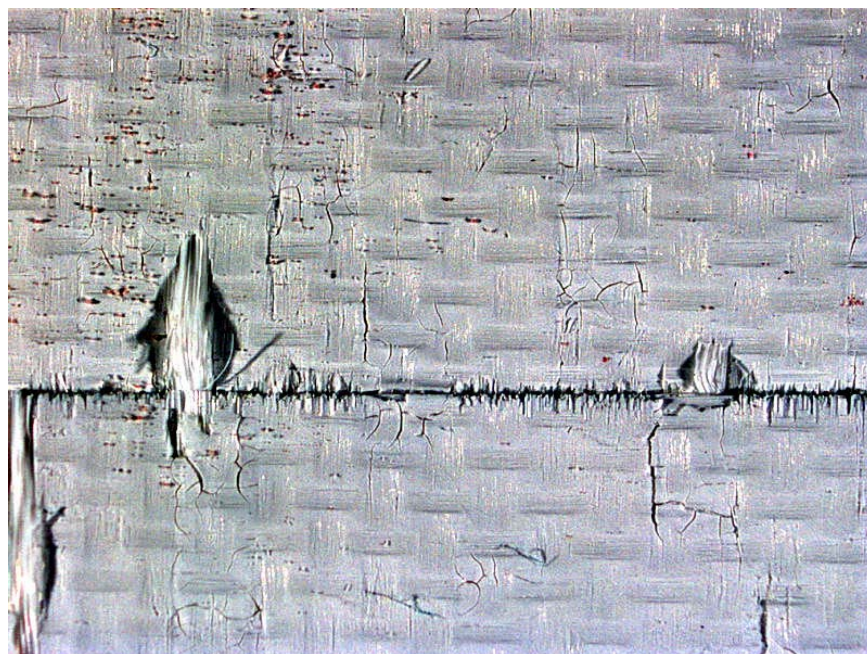
Figure 102: Close-up of the “re-sintered” notch of the N720/A specimen tested in creep at -5.0 MPa at 1200 °C in steam for 100 h.

The fact that a specimen was “re-sintered” after failure in the steam environment while undergoing compression also suggests that some additional sintering is occurring in steam, but this sintering, or perhaps coarsening, of the alumina grains in steam is overpowered by the corrosion mechanisms. The analysis of all specimens using TEM

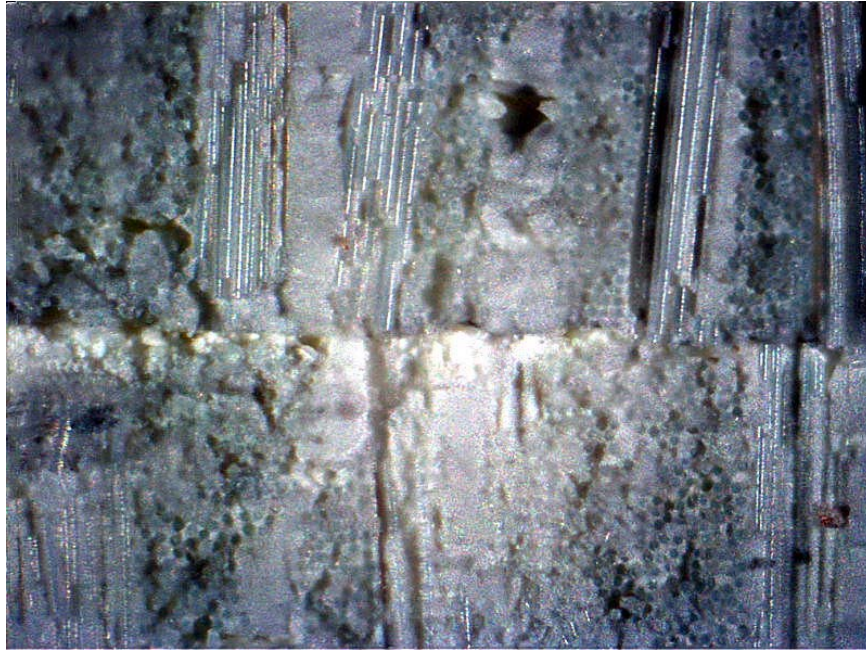
Figure 103: Close-up of the side of the “re-sintered” notch of the N720/A specimen tested in creep at - 5.0 MPa at 1200 °C in steam for 100 h.

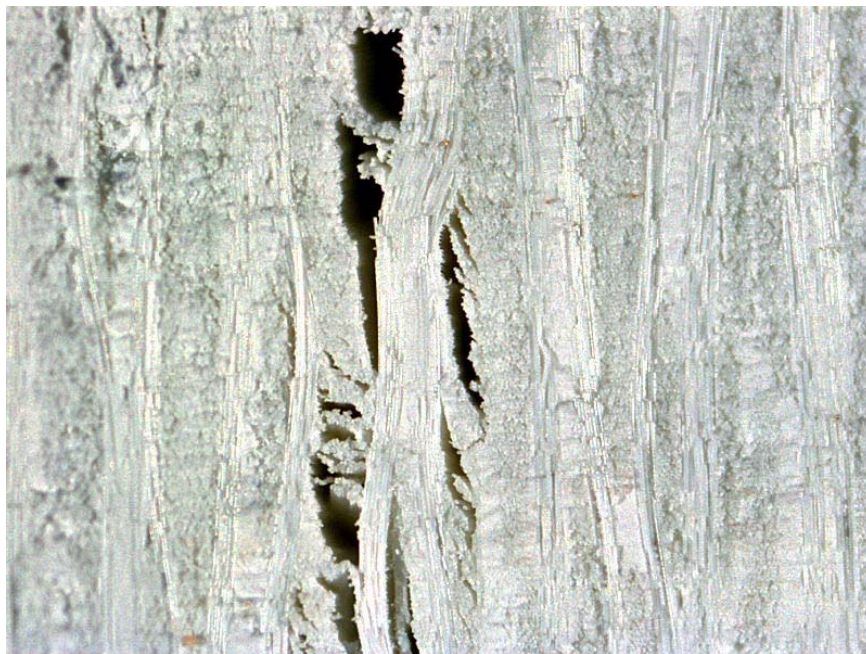
Figure 104: Close-up of the midplane of the N720/A specimen tested in creep at -5.0 MPa at 1200 °C in steam for 100 h.

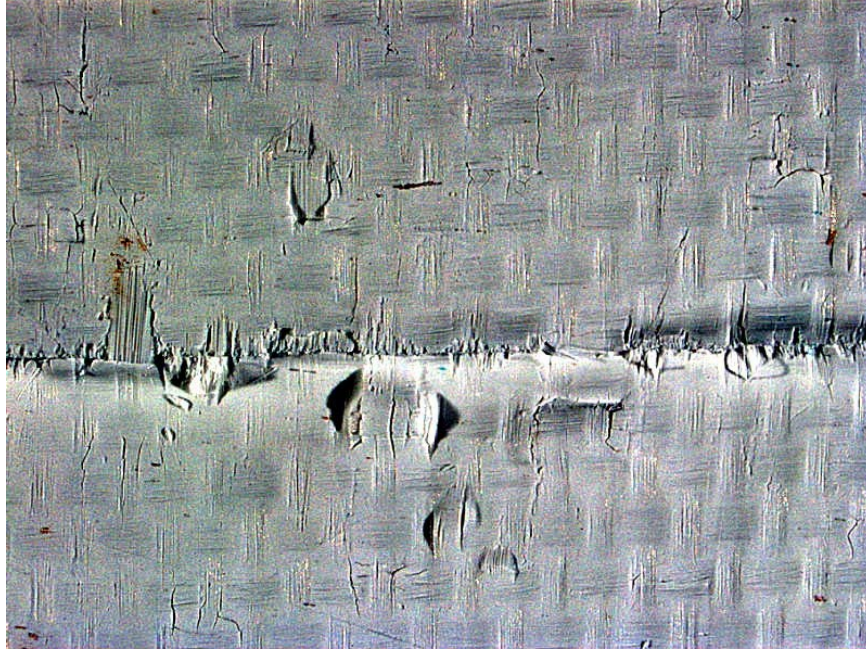
Figure 105: Close-up of the “re-sintered” notch of the N720/A specimen tested in creep at -5.0 MPa at 1200 °C in steam for 100 h.

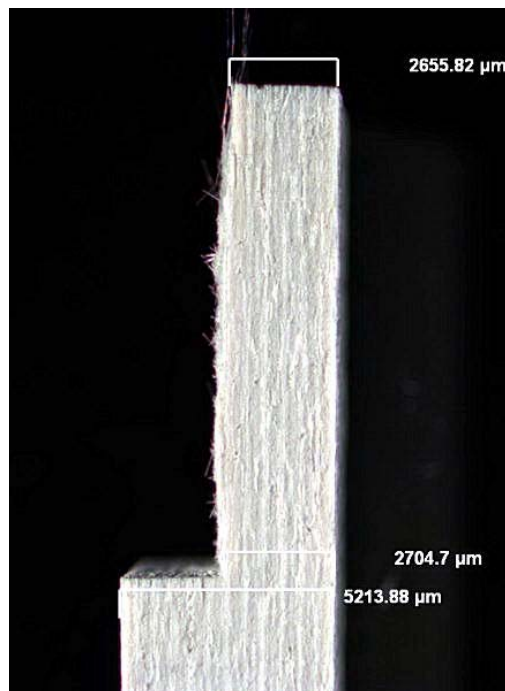
Figure 106: Side view of fracture surface of the N720/A specimen aged in steam at 1200°C for 24 h under zero load before compression to failure.

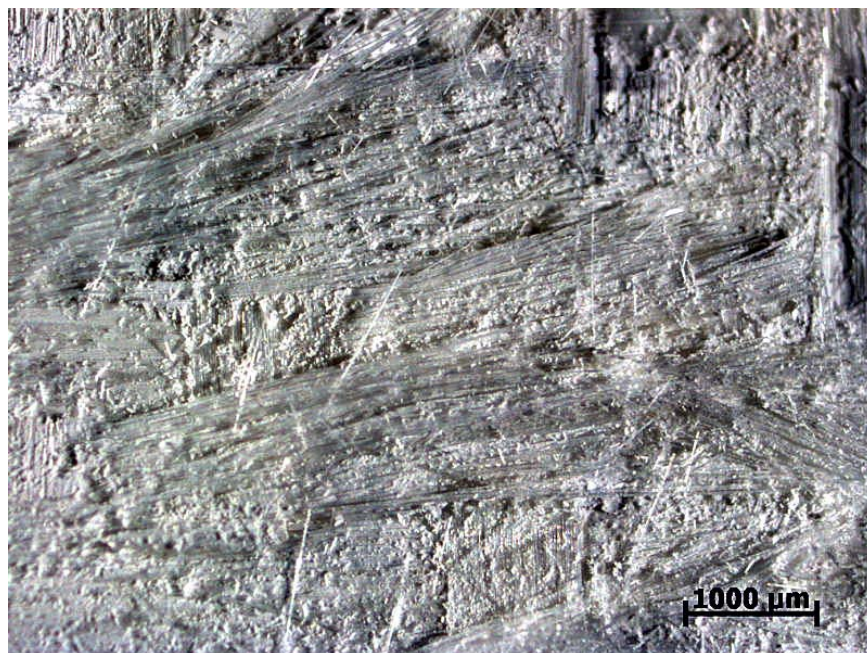
Figure 107: Close-up of the fracture surface of the N720/A specimen aged in steam at 1200°C for 24 h under zero load before compression to failure.

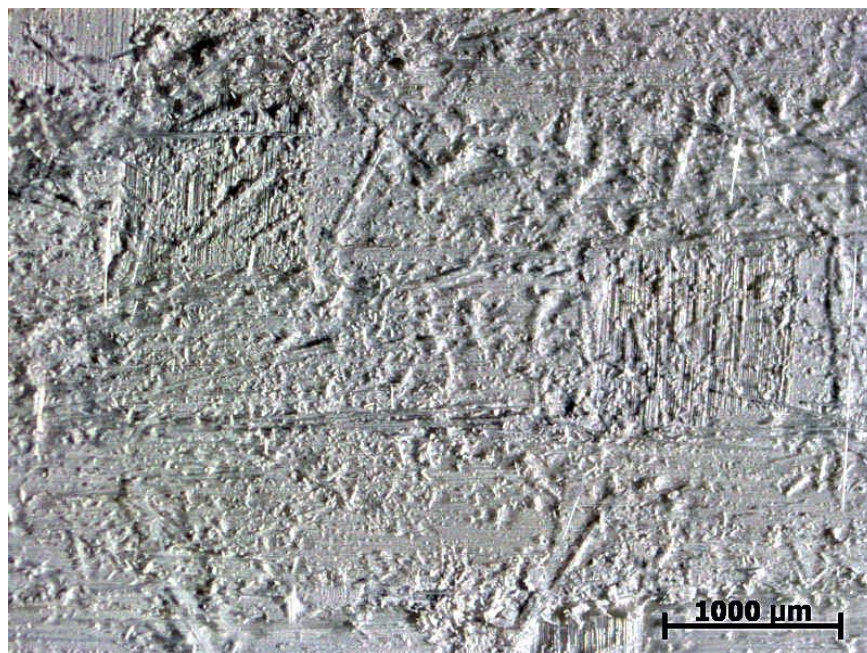
Figure 109: Close-up of the fracture surface of the N720/A specimen aged in steam at 1200°C for 24 h under zero load before compression to failure.

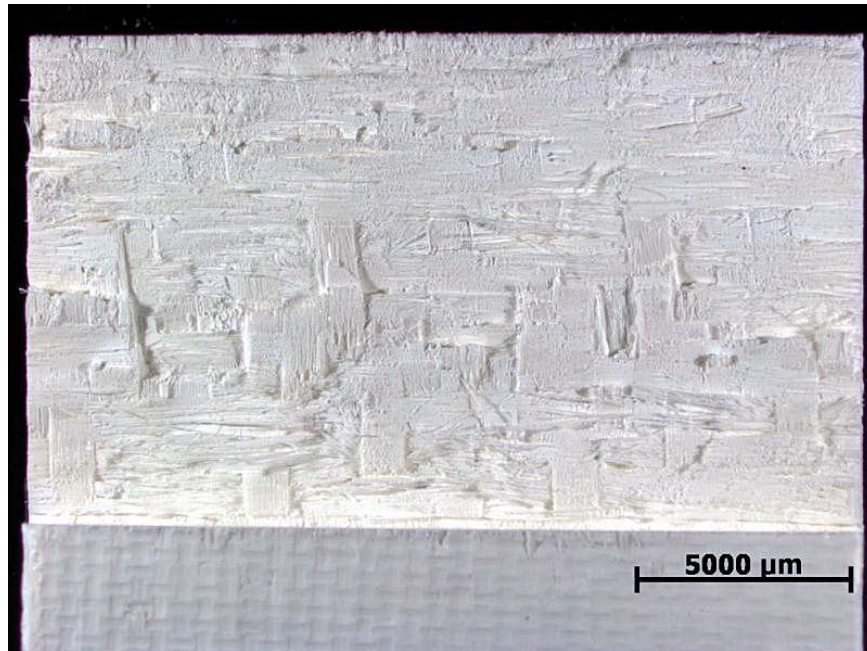
Figure 111: Fracture surface of piece A of the N720/A specimen tested in creep at -4.0 MPa at 1200°C in steam for 100 h. This specimen was unloaded and the temperature reduced for about 3 h before resuming the test.

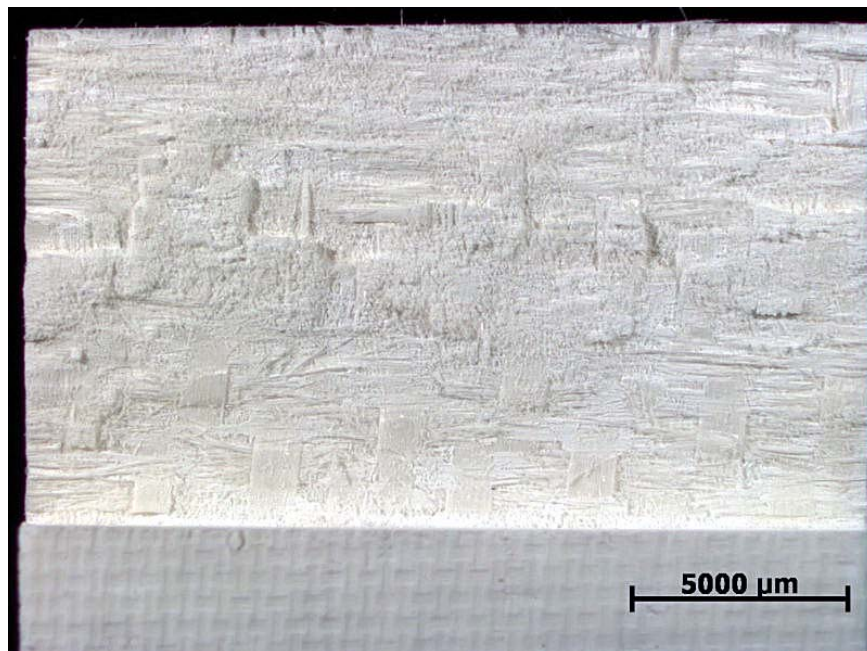
Figure 112: Fracture surface of piece B of the N720/A specimen tested in creep at -4.0 MPa at 1200°C in steam for 100 h. This specimen was unloaded and the temperature reduced for about 3 h before resuming the test.

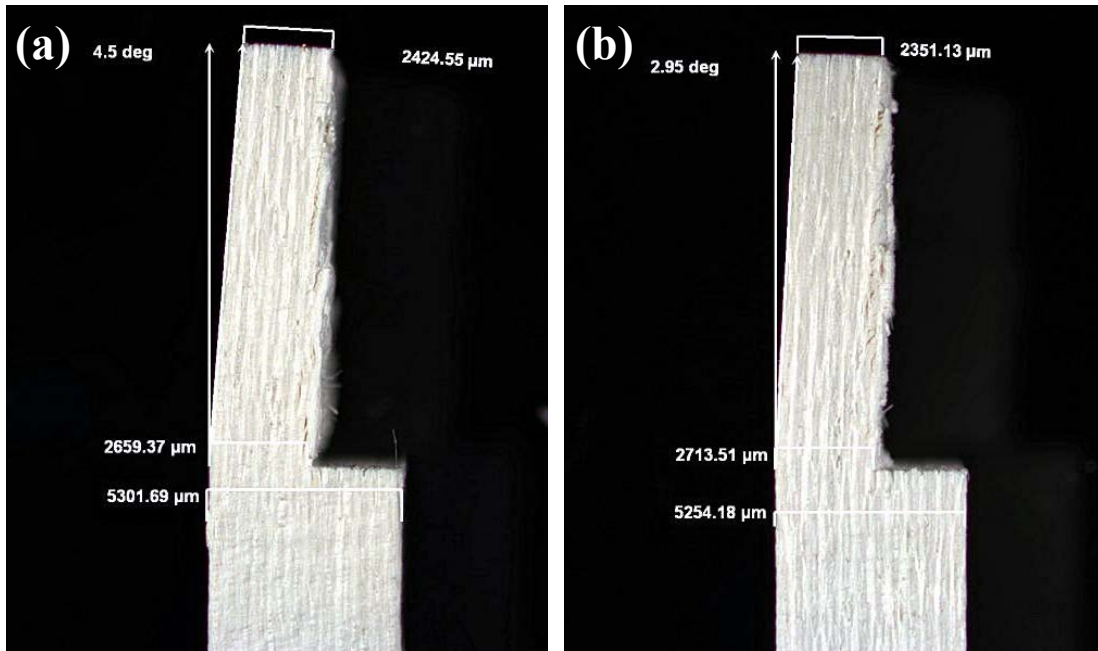
Figure 113: Side views of the fracture surfaces of the N720/A specimen tested in creep at -4.0 MPa at 1200 °C in steam for 100 h. This specimen was unloaded and the temperature reduced for about 3 h before resuming the test. (a) is of Piece A and (b) is of Piece B.

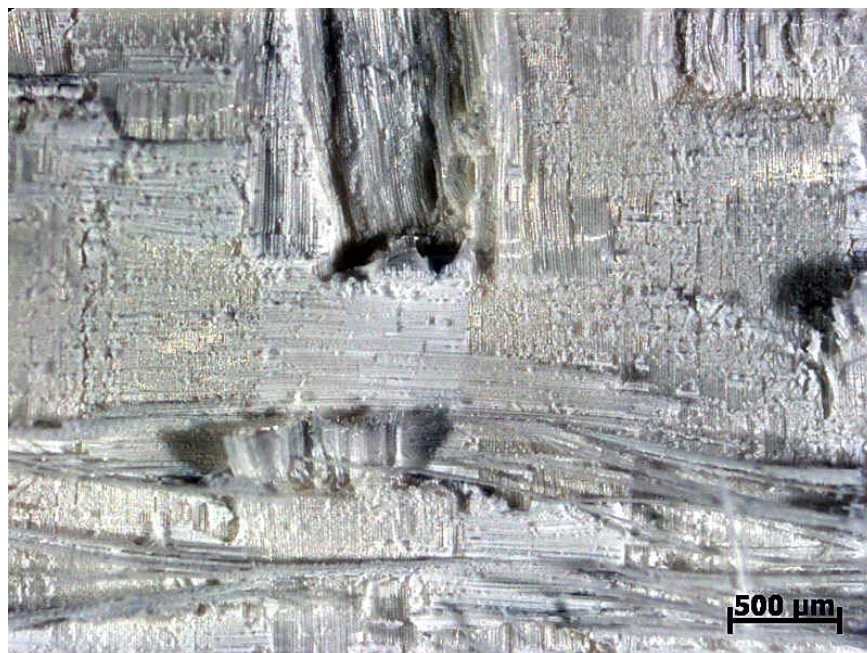
Figure 115: Close-up of the fracture surface of piece A of the N720/A specimen tested in creep at -4.0 MPa at 1200°C in steam for 100 h. This specimen was unloaded and the temperature reduced for about 3 h before resuming the test.

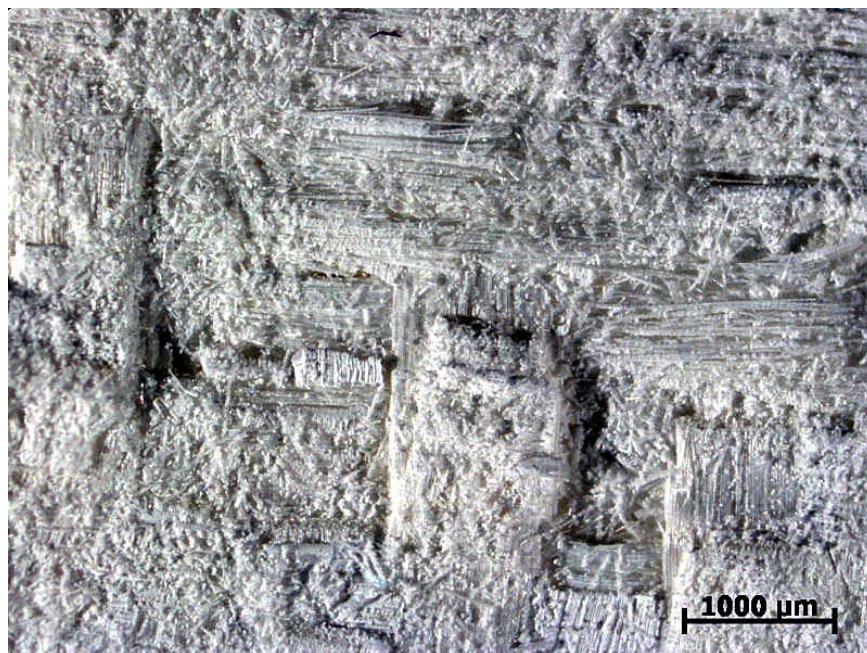
Figure 117: Close-up of the fracture surface of piece A of the N720/A specimen tested in creep at -4.0 MPa at 1200°C in steam for 100 h. This specimen was unloaded and the temperature reduced for about 3 h before resuming the test.

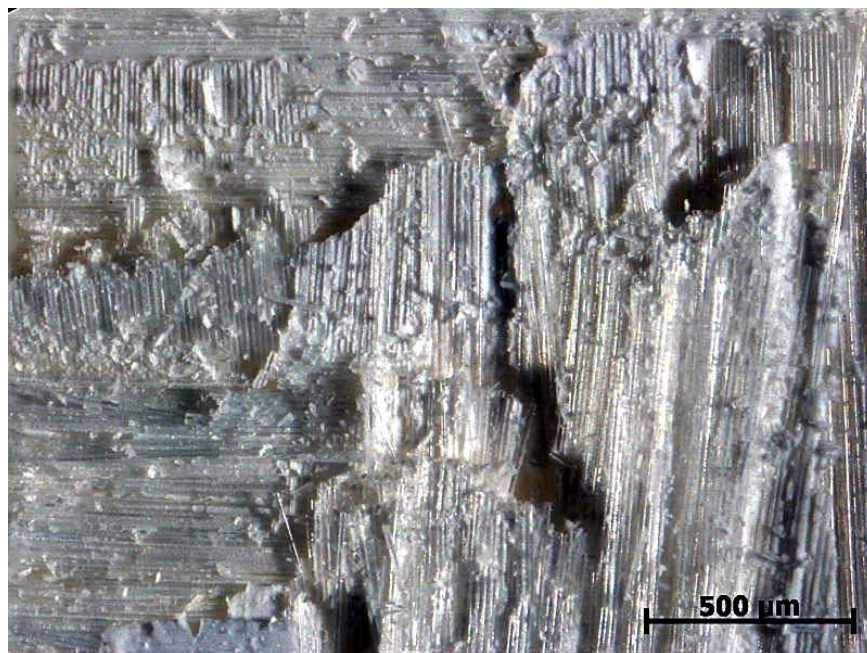
Figure 119: Close-up of the fracture surface of piece A of the N720/A specimen tested in creep at -4.0 MPa at 1200°C in steam for 100 h. This specimen was unloaded, but remained at 1200°C for the duration of the test.

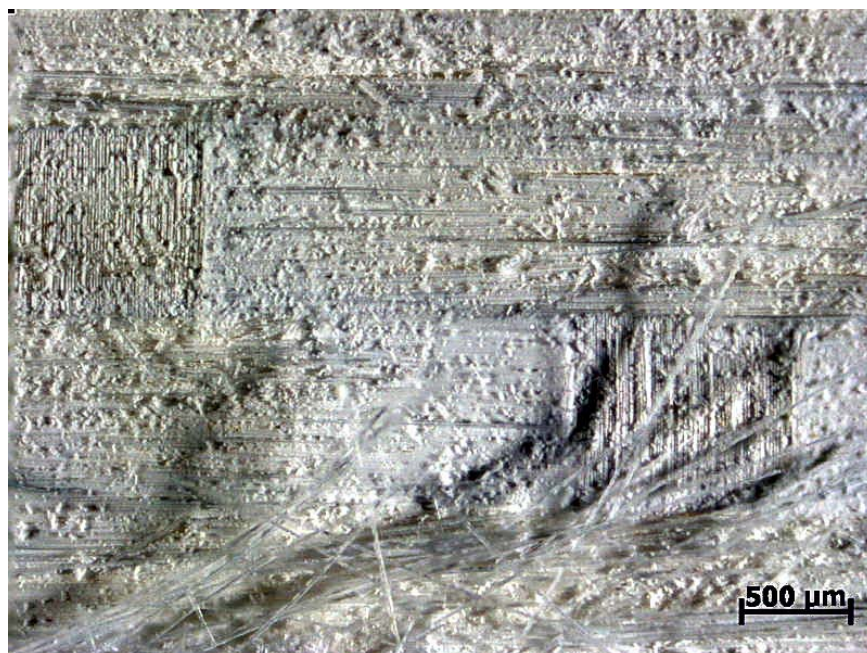
Figure 120: Close-up of the fracture surface of piece A of the N720/A specimen tested in creep at -4.0 MPa at 1200°C in steam for 100 h. This specimen was unloaded, but remained at 1200°C for the duration of the test.

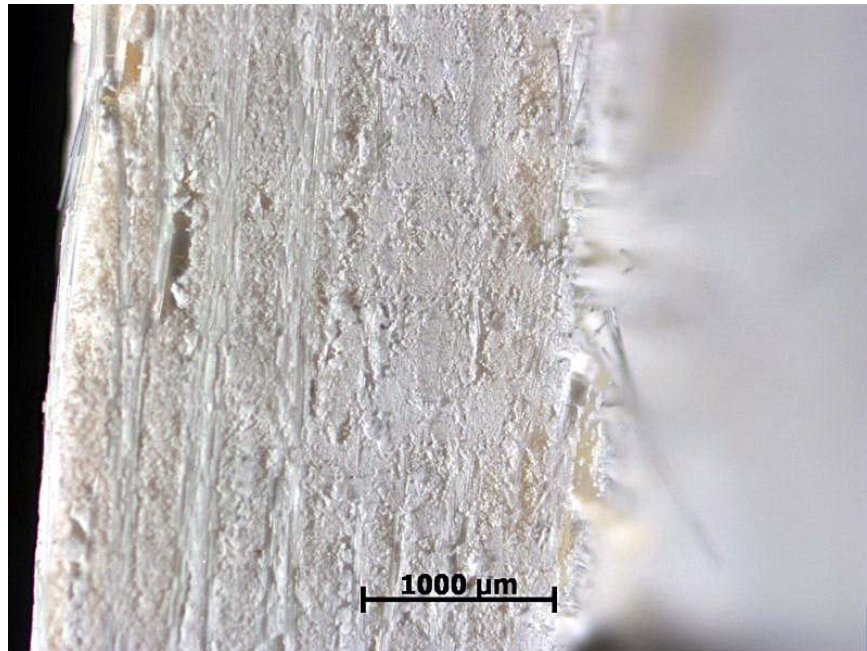
Figure 121: Side view of piece A of the N720/A specimen tested in creep at -4.0 MPa at 1200 °C in steam for 100 h. This specimen was unloaded, but remained at 1200°C for the duration of the test. Note what appears to be corrosion

The stress-enhanced corrosion of alumina is also a likely candidate for the decrease in creep performance. It is well known that water causes stress corrosion in monolithic alumina, and Ebrahimi et al. [15,16] reported that water also caused stress corrosion in both MgO doped alumina and undoped alumina. It was also found that the creep response improved for polycrystalline alumina as the grain size increased up to $\sim 35 \mu\text{m}$ [15]. The interlaminar shear strength of N720/A could perhaps be increased if the current small grain size, $\sim 0.5 \mu\text{m}$, was increased while still maintaining porosity in order to achieve crack deflection around the fibers.

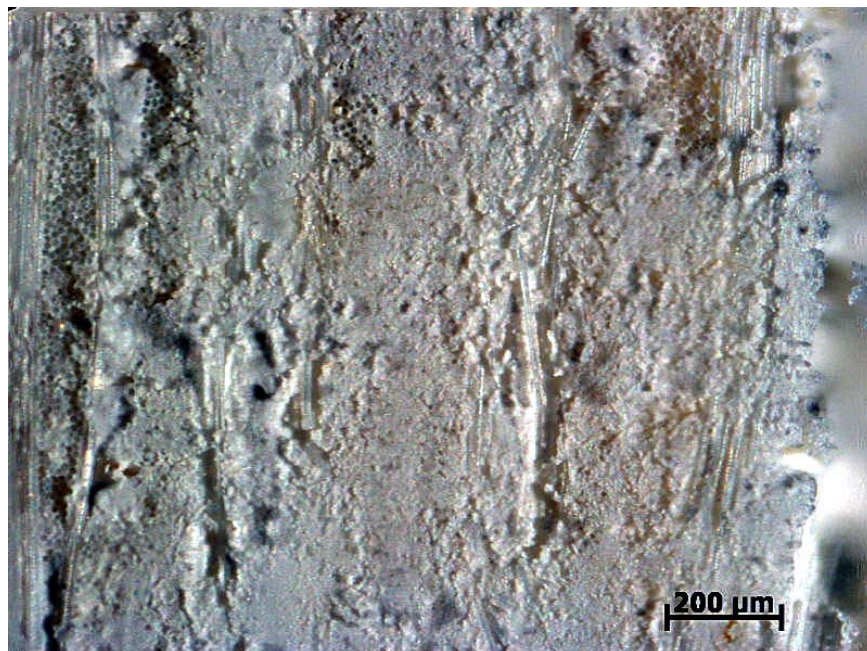
Figure 122: Close-up of Figure 121.

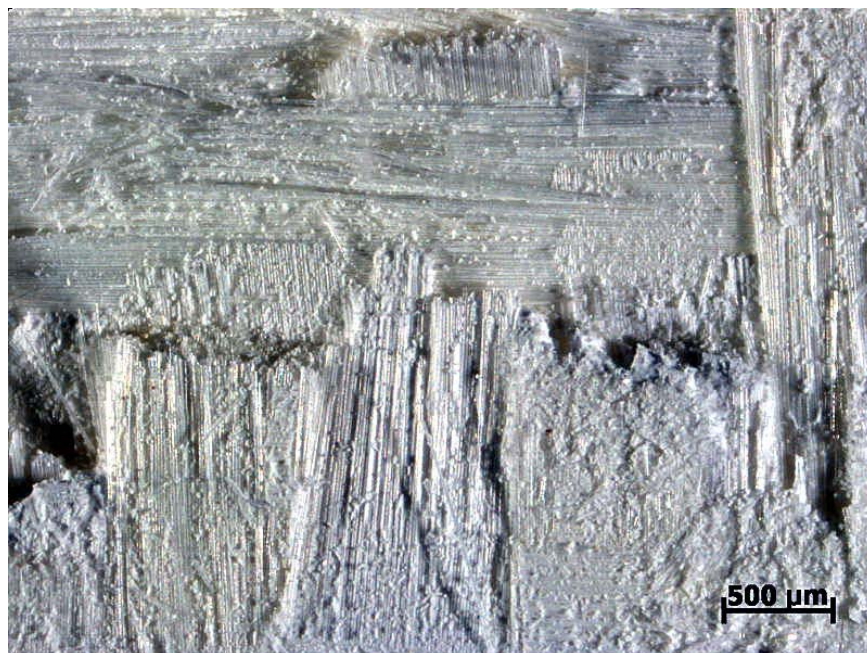
Figure 123: Close-up of the fracture surface of piece B of the N720/A specimen tested in creep at -4.0 MPa at 1200°C in steam for 100 h. This specimen was unloaded, but remained at 1200°C for the duration of the test.

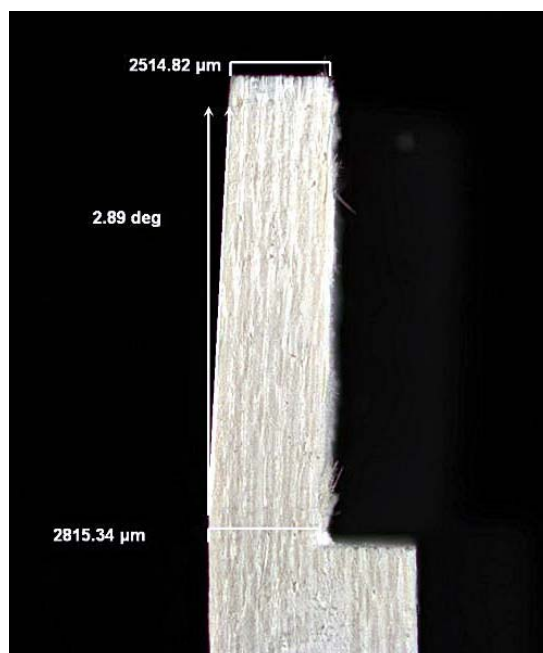
Figure 124: Side view of the fracture surface of piece B of the N720/A specimen tested in creep at -4.0 MPa at 1200°C in steam for 100 h. This specimen was unloaded, but remained at 1200°C for the duration of the test.

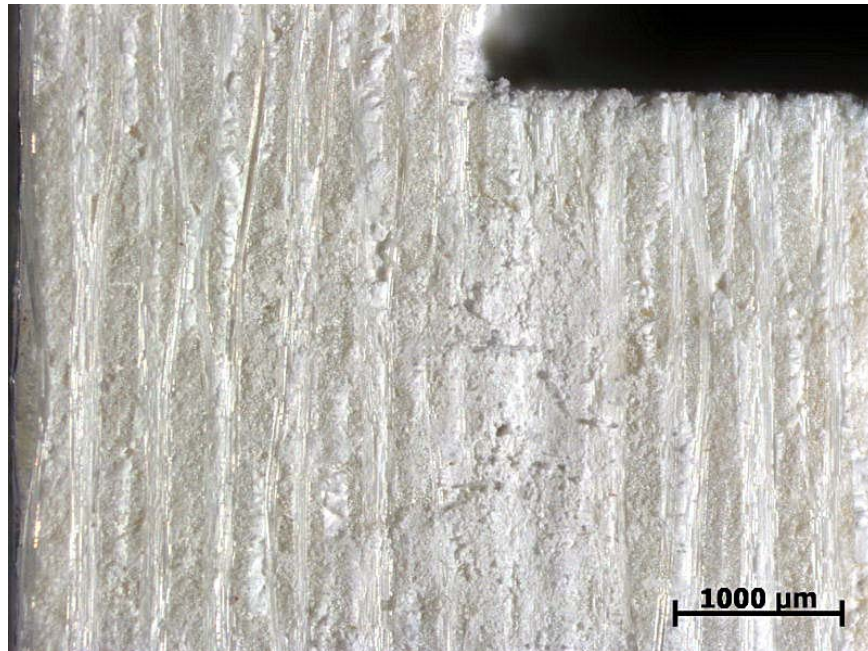
Figure 125: Close-up of Figure 124.

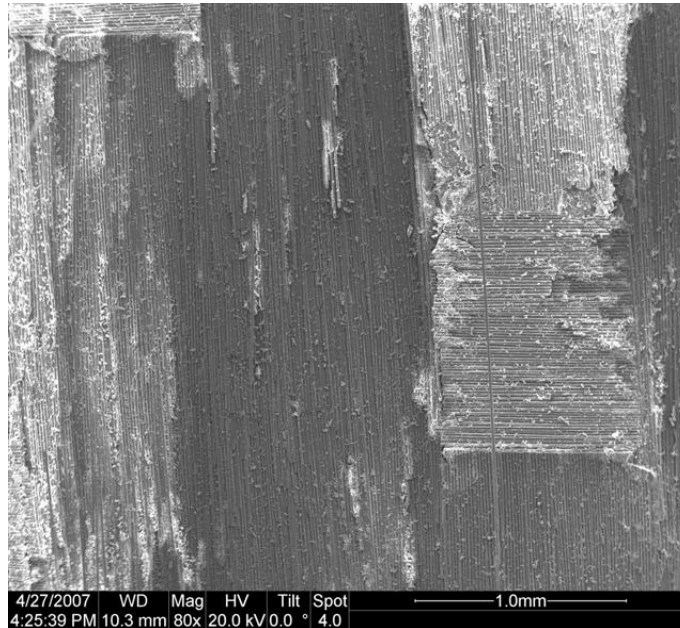
Figure 126: Fracture surface of the N720/A specimen tested in compression to failure in air at 1200°C.

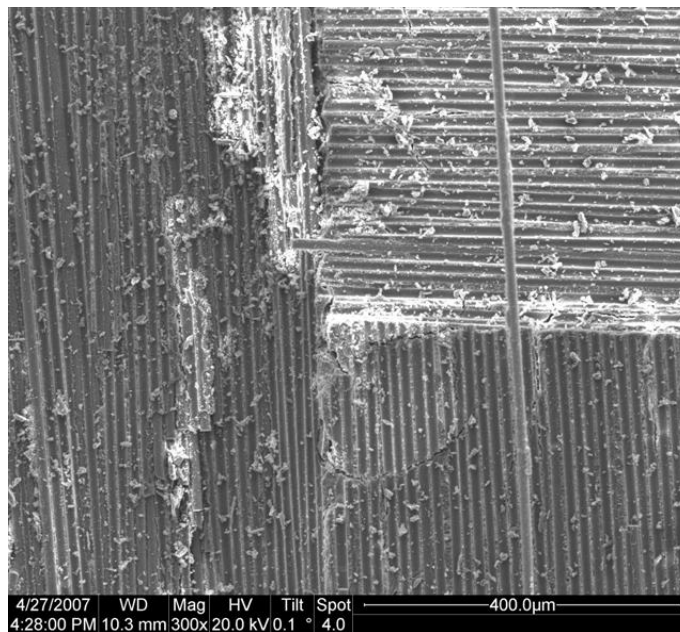
Figure 127: Fracture surface of the N720/A specimen tested in compression to failure in air at 1200°C.

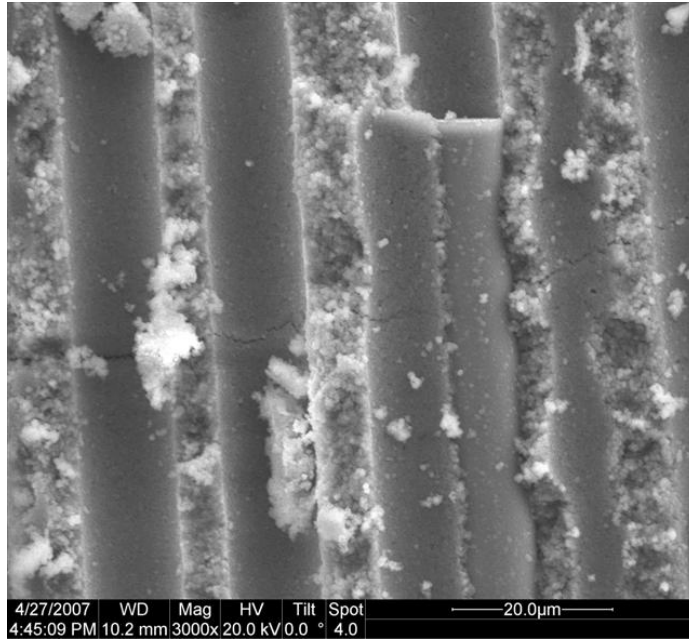
Figure 128: Fracture surface of the N720/A specimen tested in compression to failure in air at 1200°C.

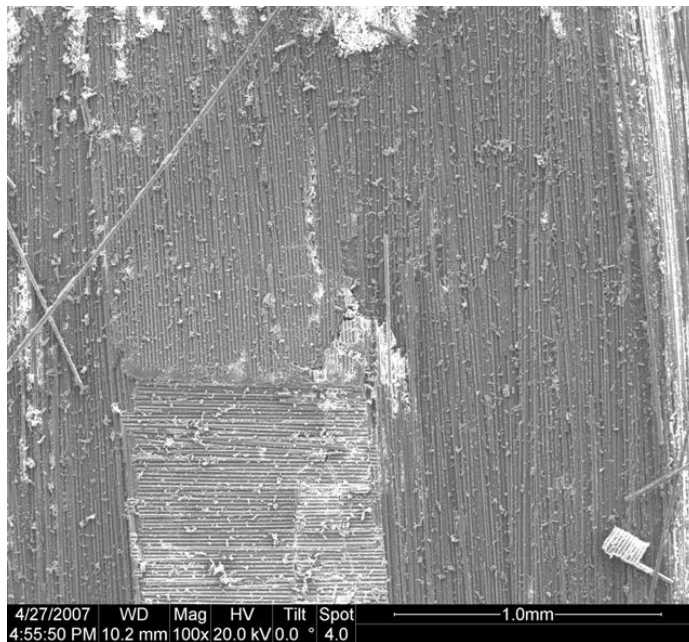
Figure 129: Fracture surface of the N720/A specimen tested in compression to failure in air at 1200°C.

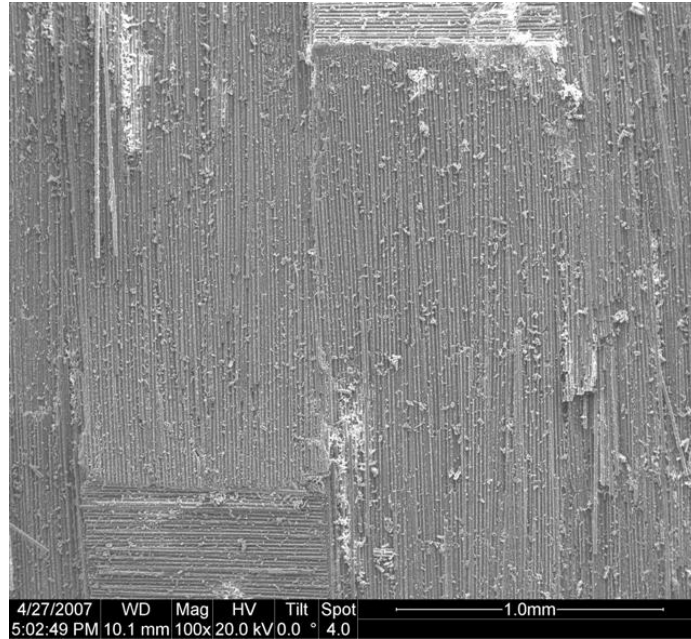
Figure 130: Fracture surface of the N720/A specimen tested in compression to failure in air at 1200°C.

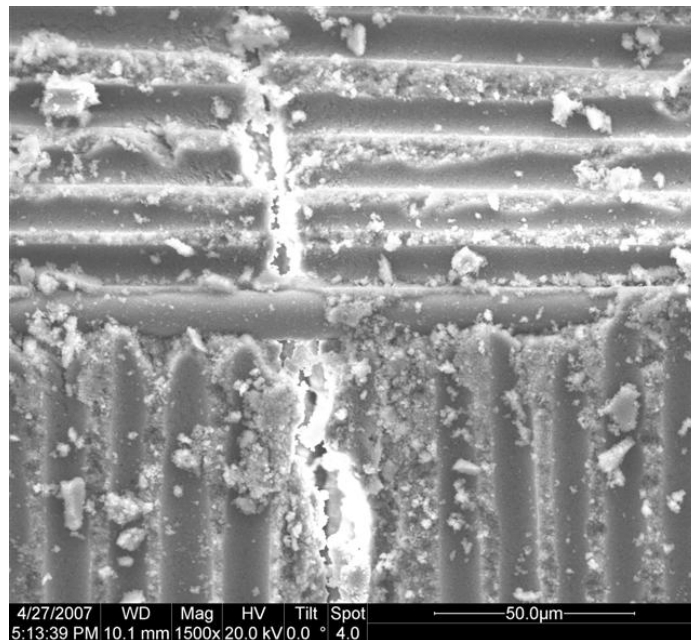
Figure 131: Fracture surface of the N720/A specimen tested in compression to failure in air at 1200°C.

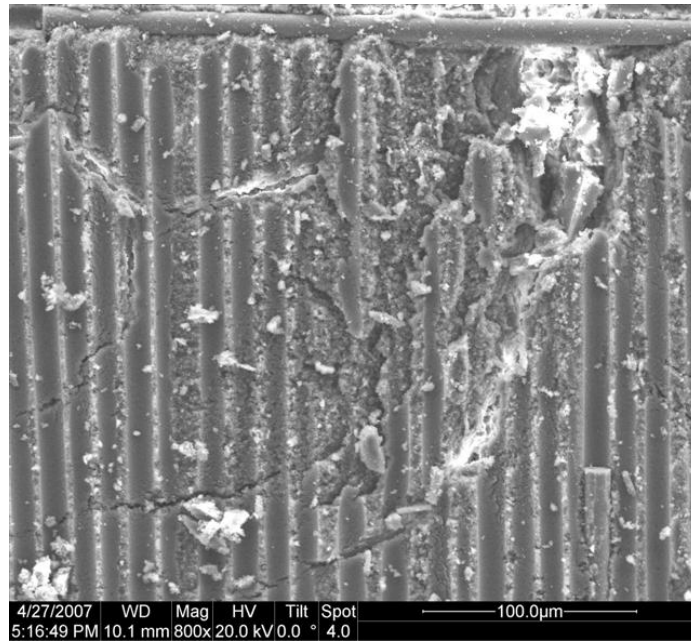
Figure 132: Fracture surface of the N720/A specimen tested in compression to failure in air at 1200°C.

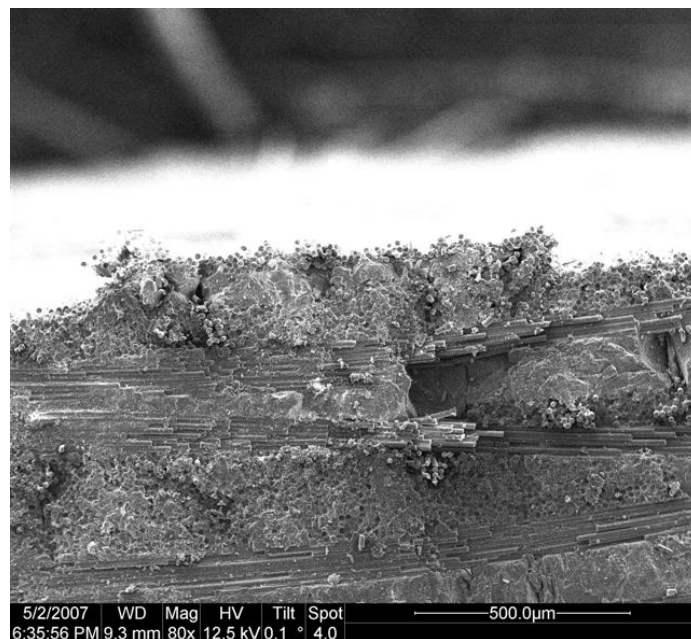
Figure 133: Side of the fracture surface of the N720/A specimen tested in compression to failure in air at 1200°C.

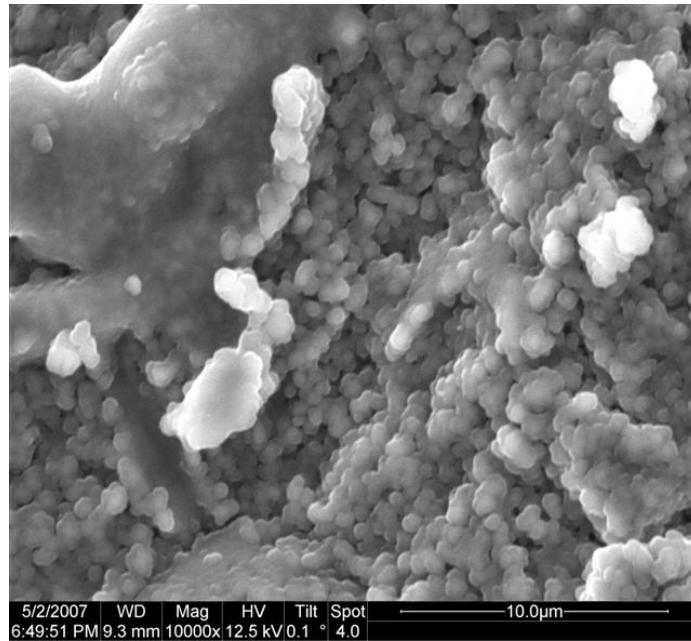
Figure 134: Side of the fracture surface of the N720/A specimen tested in compression to failure in air at 1200°C.

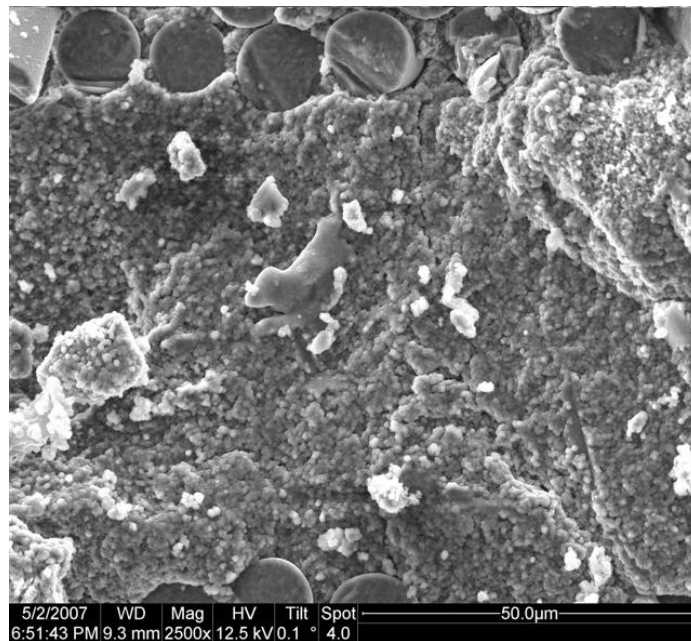
Figure 135: Side of the fracture surface of the N720/A specimen tested in compression to failure in air at 1200°C.

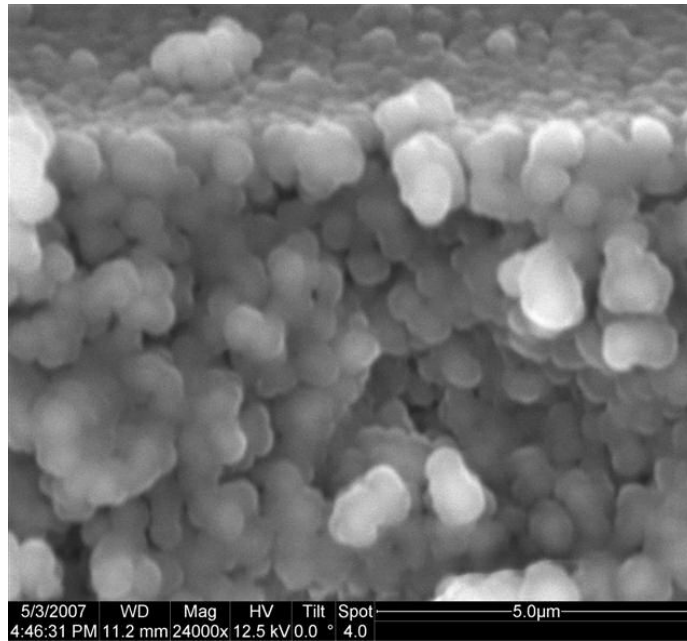
Figure 136: Fracture surface of the N720/A specimen tested in compression to failure in air at 1200°C.

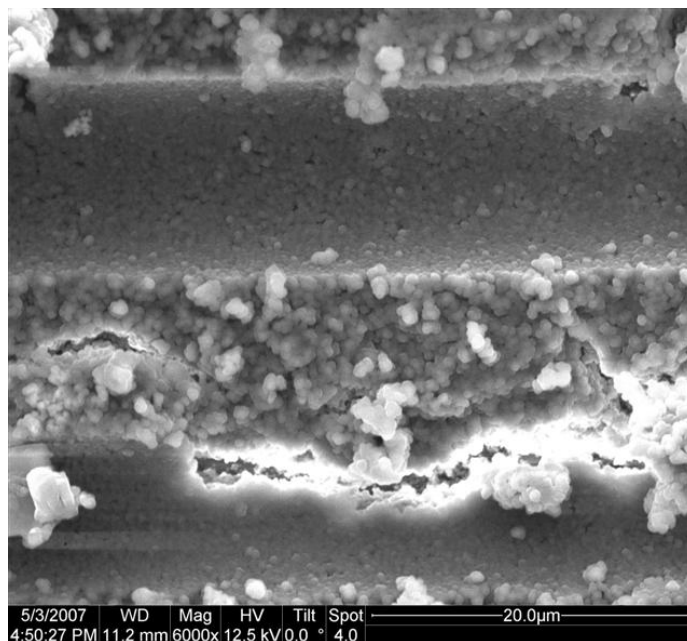
Figure 137: Fracture surface of the N720/A specimen tested in compression to failure in air at 1200°C.

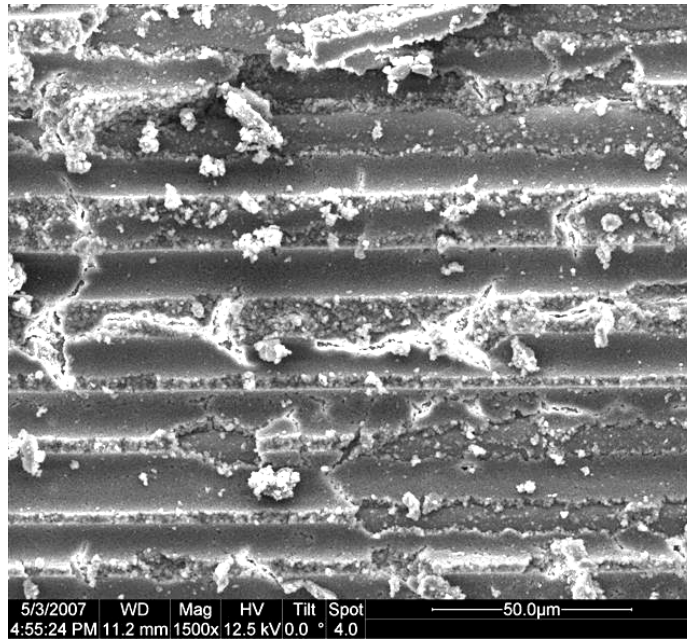
Figure 138: Fracture surface of the N720/A specimen tested in compression to failure in air at 1200°C.

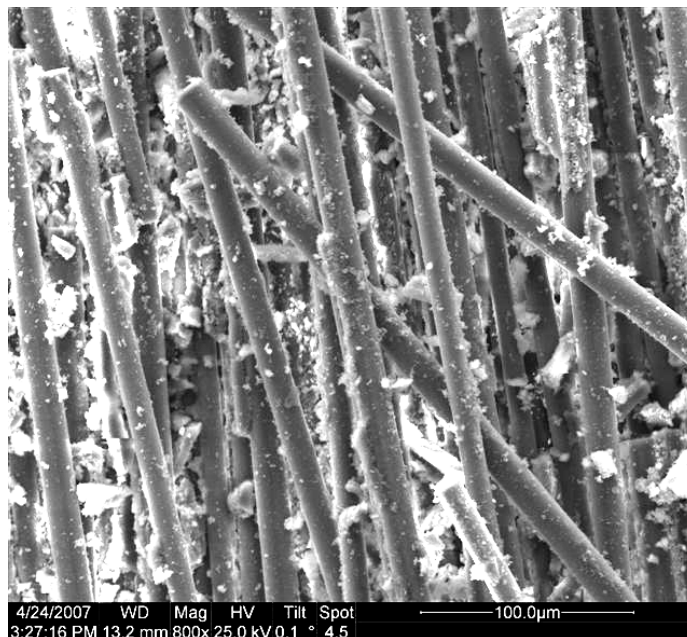
Figure 139: Fracture surface of the N720/A specimen tested in -6.5 MPa creep in air at 1200°C.

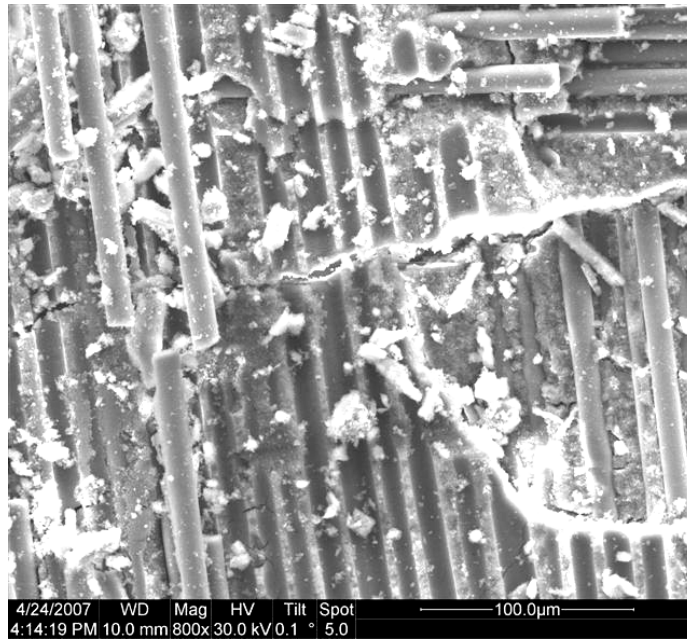
Figure 140: Fracture surface of the N720/A specimen tested in -6.5 MPa creep in air at 1200°C .

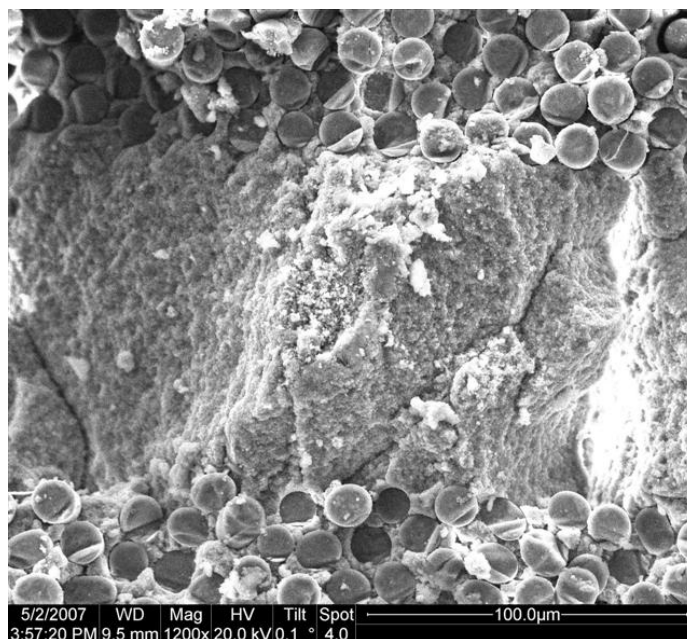
Figure 141: Side of the fracture surface of the N720/A specimen tested in -6.5 MPa creep in air at 1200°C .

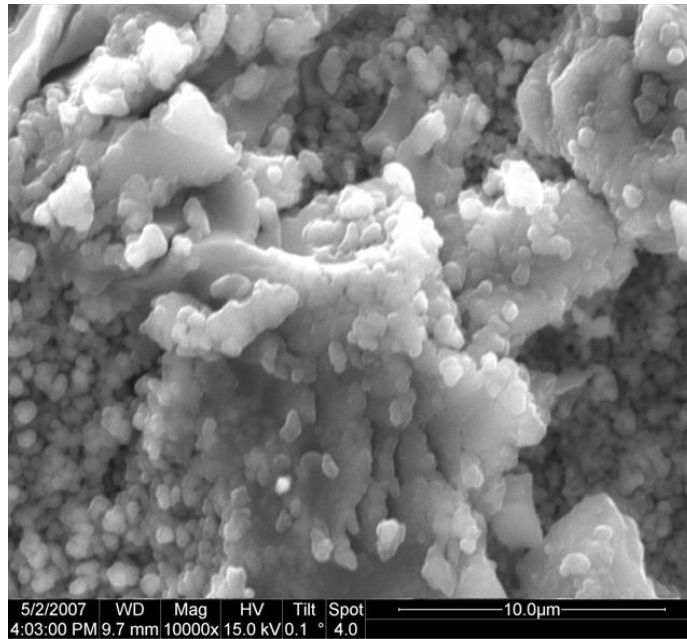
Figure 142: Side of the fracture surface of the N720/A specimen tested in –6.5 MPa creep in air at 1200°C.

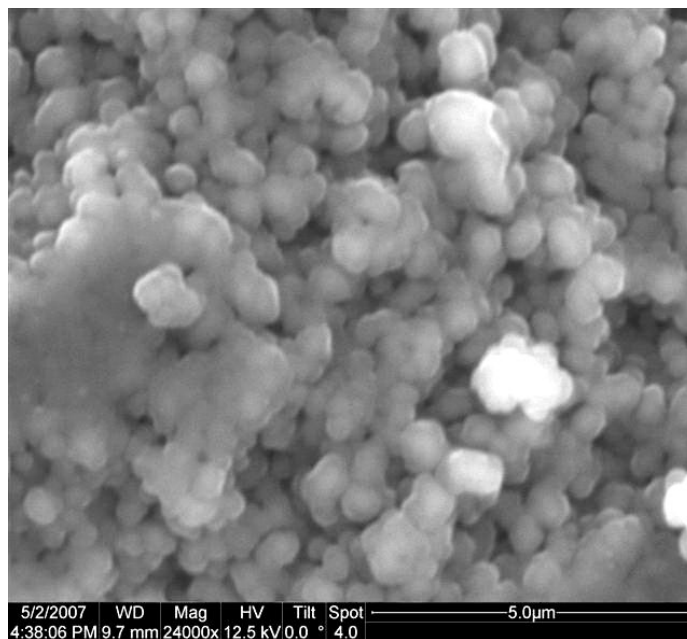
Figure 143: Side of the fracture surface of the N720/A specimen tested in –6.5 MPa creep in air at 1200°C.

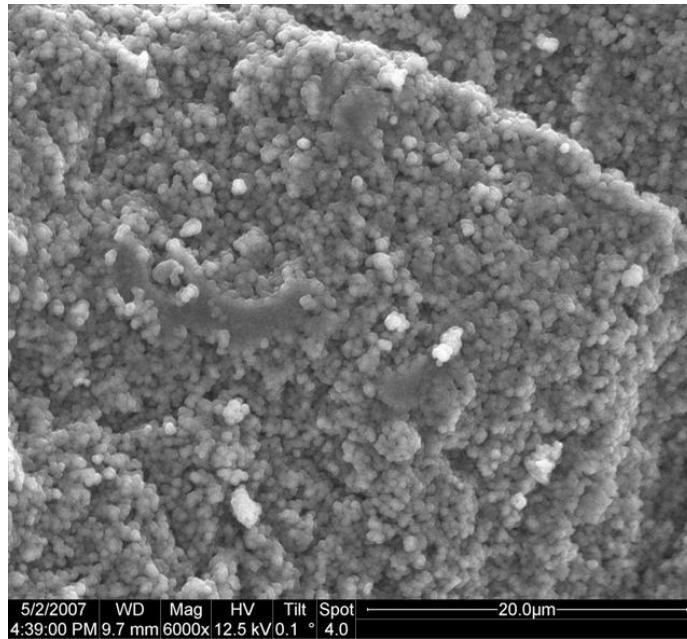
Figure 144: Side of the fracture surface of the N720/A specimen tested in –6.5 MPa creep in air at 1200°C.

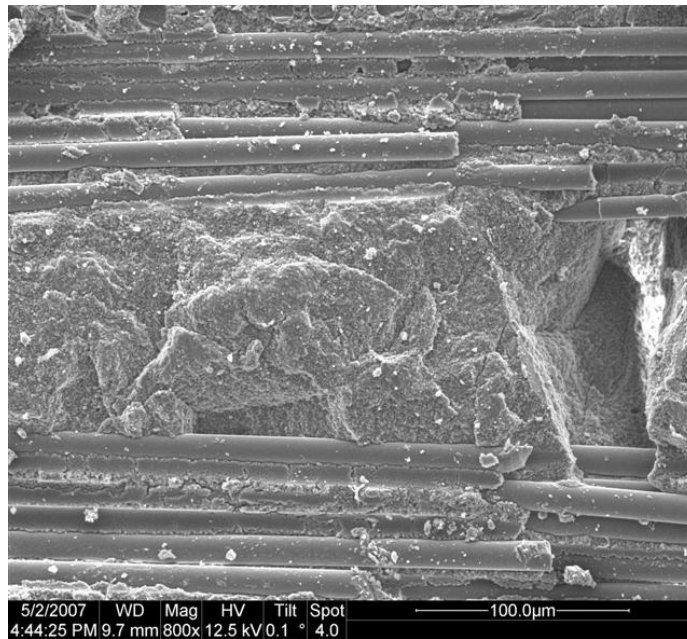
Figure 145: Side of the fracture surface of the N720/A specimen tested in –6.5 MPa creep in air at 1200°C.

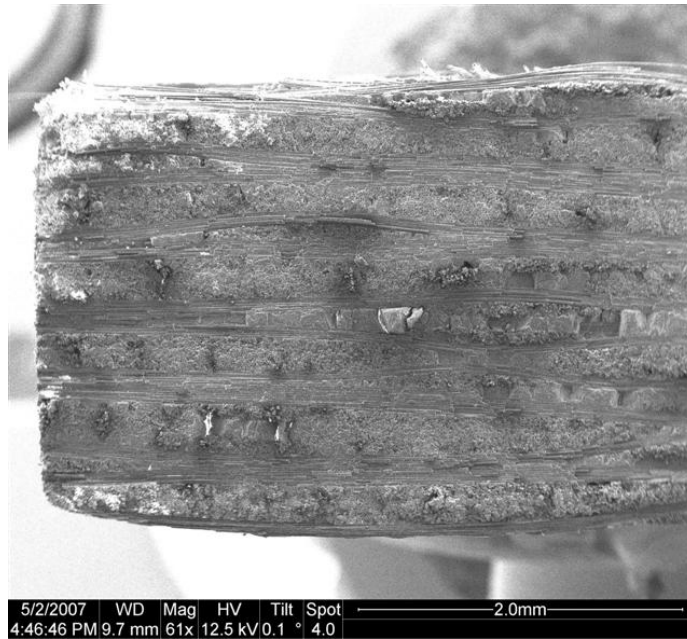
Figure 146: Side of the fracture surface of the N720/A specimen tested in -6.5 MPa creep in air at 1200°C .

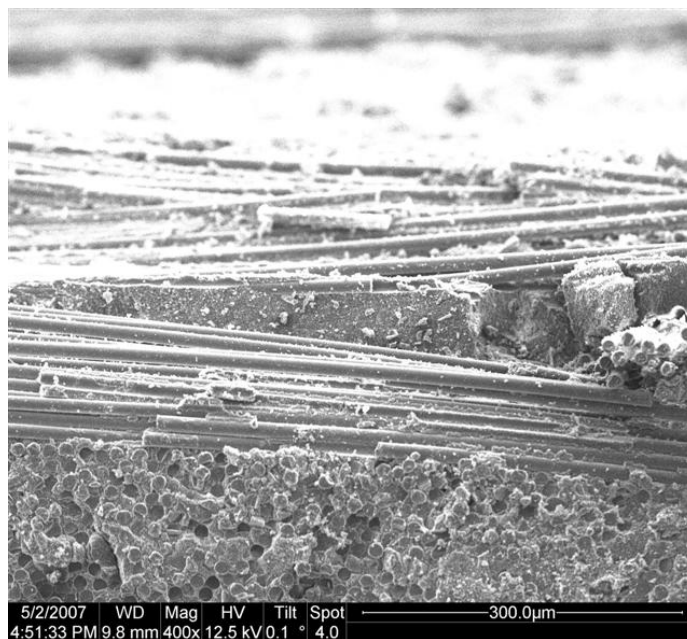
Figure 147: Side of the fracture surface of the N720/A specimen tested in -6.5 MPa creep in air at 1200°C .

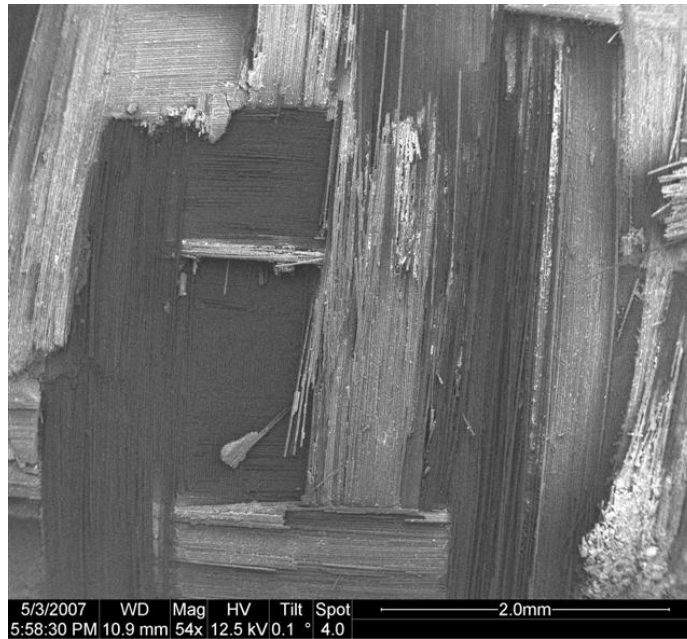
Figure 148: Fracture surface of the N720/A specimen tested in -6.5 MPa creep in air at 1200°C .
